DSTO-TR-0229

Investigation of Fatigue Cracking
on LAU-7/A Launcher Housing

**Airframes and Engines Division
Aeronautical and Maritime Research Laboratory**

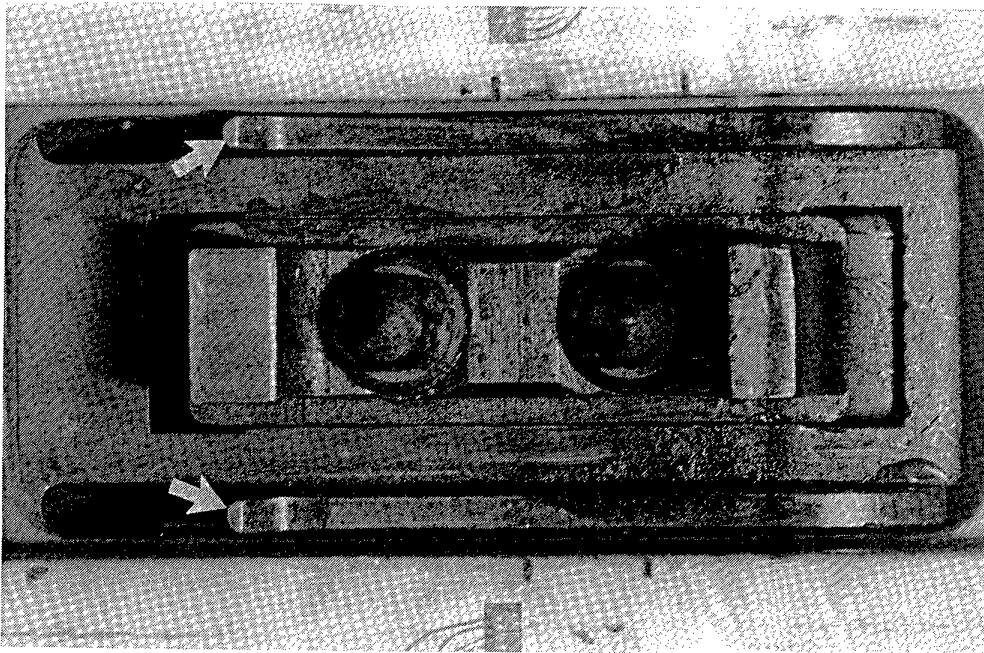
Figure 3. Forward snubber region with forward to the left. The snubber plates (arrowed) are in the engaged position. The hold-back detent mechanism and striker points are visible in the centre.

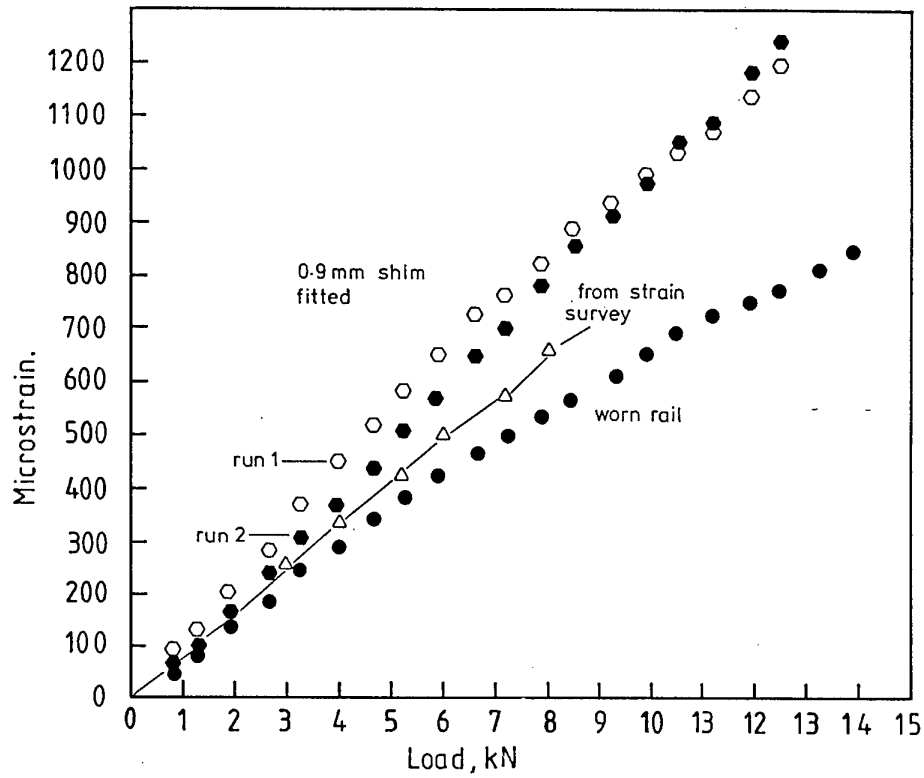
The introduction of a shim at the upper forward hanging bracket location produced higher strains during fatigue testing, see Figure 15, and this appeared to be the result of small geometry changes in the forward hanging bracket region during testing. The small geometry changes may be attributed to wear of the upper guide rail and edges of the lower guide rail where the hanging bracket bears down under the test loading conditions. See Section 5.2 above.

Figure 15. *Effect of shimming forward hanging bracket in the guide rails during a fatigue test.*

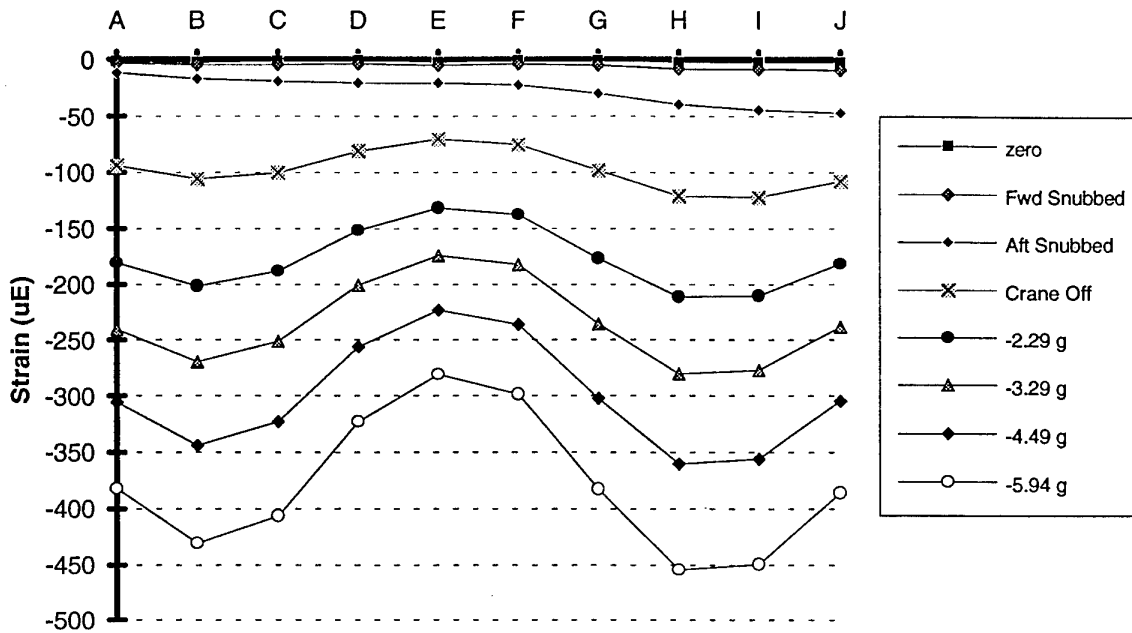
Strip gauges proved useful in detecting the peak strain lobes on the outer rail surface. These lobes occurred either side of the line of extension of the crack. Figure 20 shows the strains measured by the strip gauges for the uncracked rail of Experiment 7.

Figure 20 illustrates the various stages of the snubbing procedure and the strain response of the strip gauge on the upper rail as down loading is increased. Engagement of the forward snubbers produces no noticeable strain in the rail at any location, since the missile weight was at that time supported by the crane. Removing the crane after snubbing and allowing the 1g weight to rest on the launcher produces strain per g increments ($-85\mu\epsilon$) slightly greater than those for the 5.95g down load (-410

Figure 20. Strain results from the strip gauge on the upper rail during snubbing and subsequent down loading to 5.95g (Experiment 7). The two peaks at gauges B and H lie either side of the line of extension of the crack.

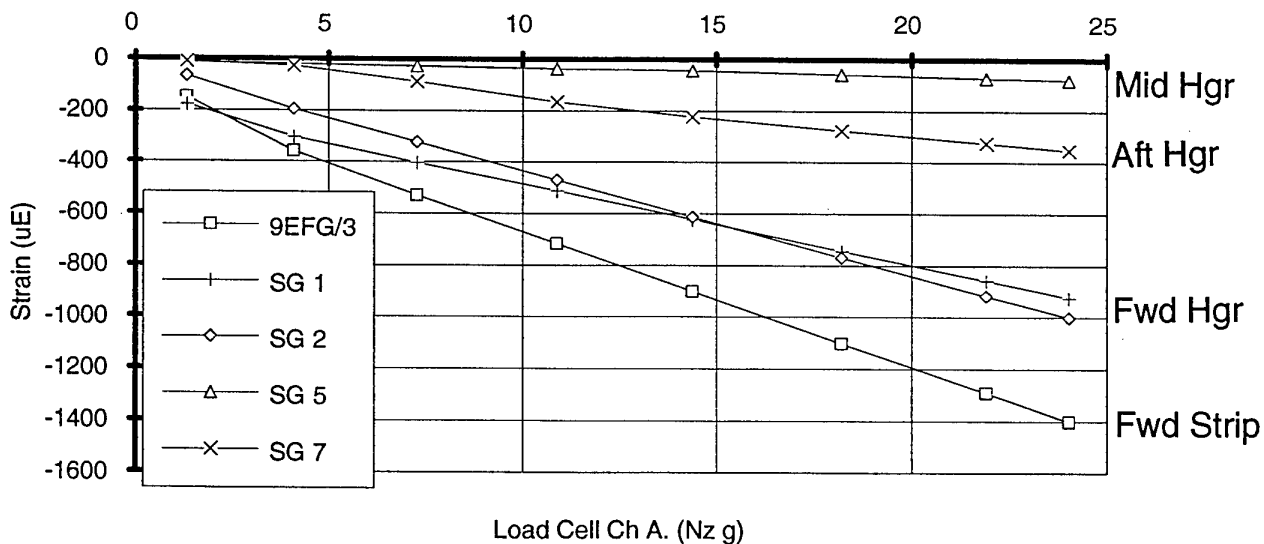
Accordingly, Figure 21 shows a strain comparison from Experiment 27 where the strip gauge results are presented as the average of those three gauges. The maximum load was a 24g download. The strains remain essentially linear above 1g and in the same proportion indicating small load path changes are confined to the low g region.

The aft strain gauges in Fig. 21 show much lower strains than the forward. This observation is common to all the experiments performed, with maximum load strains typically less than -200 to -350 $\mu\epsilon$ when the comparable strain at the forward hanger is between -900 and -1000 $\mu\epsilon$. Additionally, the maximum strain observed for the aft strain gauges 7 and 8, (-350 $\mu\epsilon$) was recorded in this experiment (27) with a down load equivalent to 24g. The corresponding peak strain at the forward hanger was approximately -2000 $\mu\epsilon$ (9H) indicating that the rail at the aft hanger was a less significant load path than the rail at the forward hanger.

Figure 21. "Load shedding" as seen by comparing the strip gauges (average of E, F and G) at the forward hanger with the single gauges at the mid and aft hangers. These strains are from the loaded rail in Experiment 27.

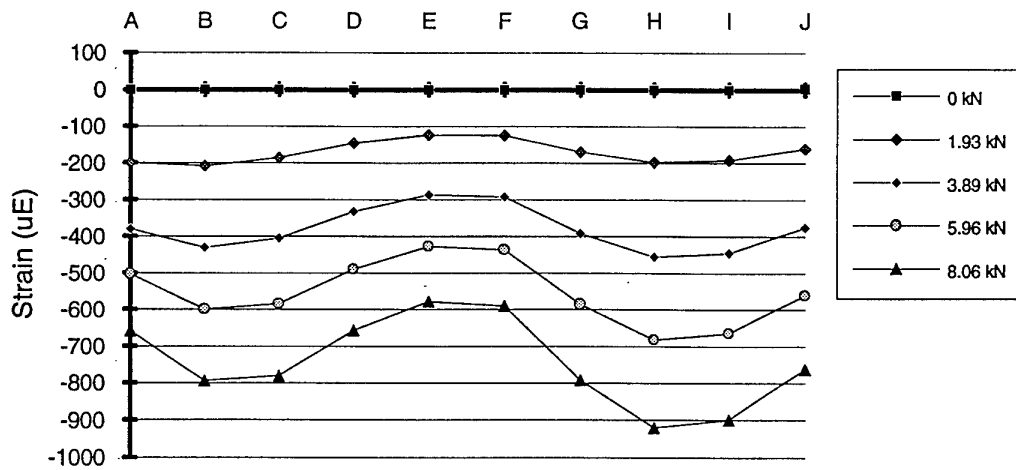
The presence of a crack adjacent to the forward snubbers appears to significantly increase the strain measured on the outer surface of the rail. The effects of rail cracking are summarized in Figure 22 from Experiments 5 and 20. Figure 22(a), from a cracked rail, shows a peak strain recording of approximately -910 $\mu\epsilon$, whilst Figure 22(b), from an uncracked rail, shows only -370 $\mu\epsilon$. Since the up load in Fig. 22(b) is half that of (a), the strain can be doubled to -740 $\mu\epsilon$. Comparison of (a) with (b) then shows that the crack has produced an increase of 23% in the peak strain.

Figure 22 (a). The effect of the crack on strains in the guide rail : Strip gauge strains at the forward snubber on the cracked lower rail during 8.5g up loading of Experiment 5.

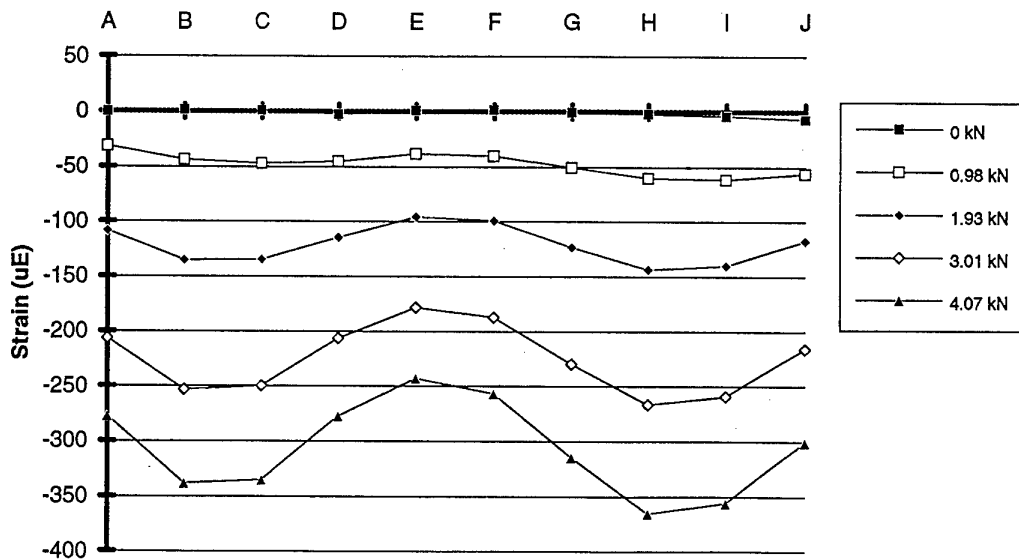
Figure 22 (b). The effect of the crack on strains in the guide rail : uncracked lower rail during up load of Experiment 20.
